# Repair or Replace

Investigating the relative GHG emissions of repairing or replacing damaged vehicle parts

Ali Rüzgar (Metsims Sustainability Consulting, Oxford, United Kingdom)  
Dr. Hüdaî Kara (Metsims Sustainability Consulting, Oxford, United Kingdom)  
Jacob Hughes (Oakdene Hollins, Aylesbury, United Kingdom)  
Monika Ecker (Allianz SE; Munich, Germany)  
Robert Knowles (Oakdene Hollins, Aylesbury, United Kingdom)  
Thomas Behl (AZT Automotive GmbH – Allianz Center for Technology, Ismaning, Germany)

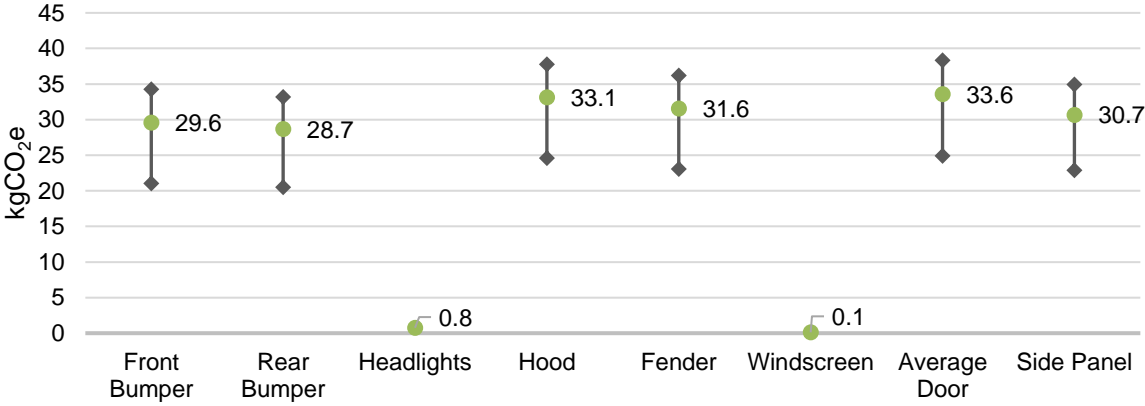
Figure 3 Range of country-specific emissions and the EU average for the repair of parts (kgCO<sub>2</sub>e)

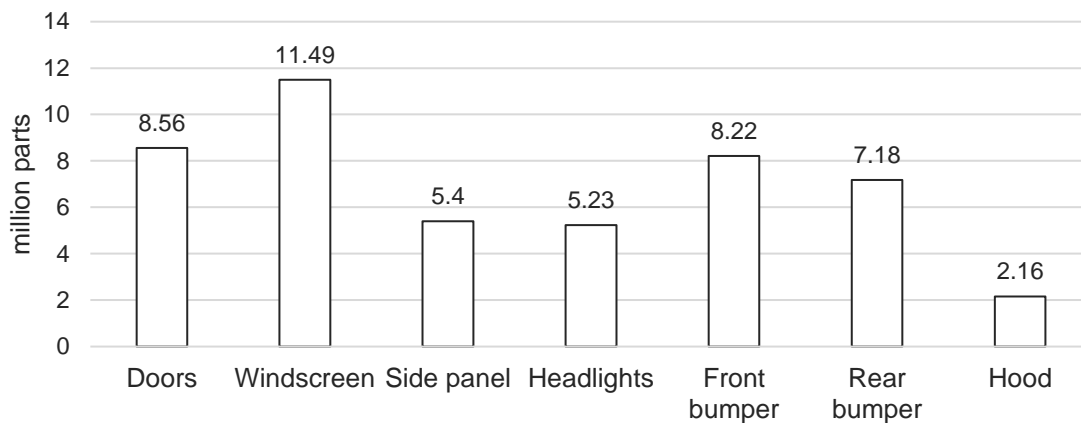
*Figure 8 Total affected car parts in Europe<sup>2</sup>*

As touched on above, this study considered the repair or replacement of nine separate vehicle parts: a front door, a rear door, a side panel, headlights, a front bumper, a rear bumper, a windscreen, a bonnet/hood, and a fender. The selection of parts was based on the frequency of damage and repair claims<sup>2</sup>. Though not presented here, an additional investigation was also undertaken on the side panel of a Ford Fiesta, as this illustrative repair example is used by the AZT to demonstrate part repair vs replacement. Of note is that this AZT demonstration<sup>3</sup> highlights significant benefits for repair over replace which were not investigated in this study. An example of this is that a repair conserves the structural integrity of the vehicle, significantly reducing the risk of corrosion over the lifetime of the repaired vehicle.

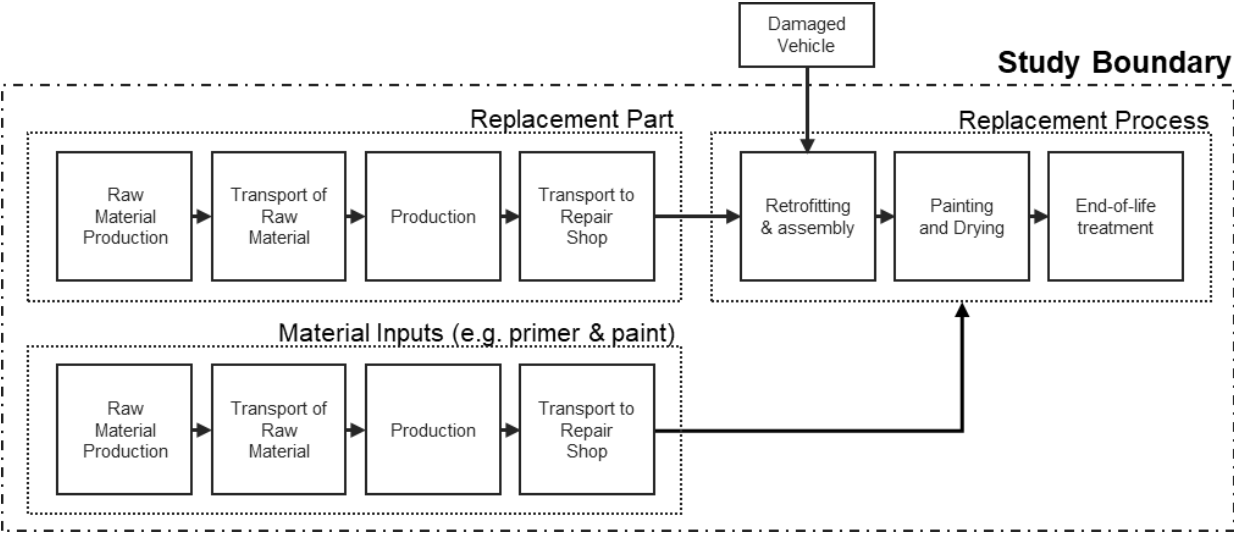
Figure 11 Study boundary for the replacement of a front door

The scenario modelled for the replacement of the front door of the ID.3 describes a scenario in which the entire part is replaced. The cradle-to-gate life cycle impacts of the production of the new part are modelled using a cut-off approach. The modelled processes start with the production of the raw materials and include the manufacture of the replacement part, transport to the workshop, painting and placement onto the receiving vehicle. Additionally, the modelling includes the removal and end-of-life treatment of the damaged part.

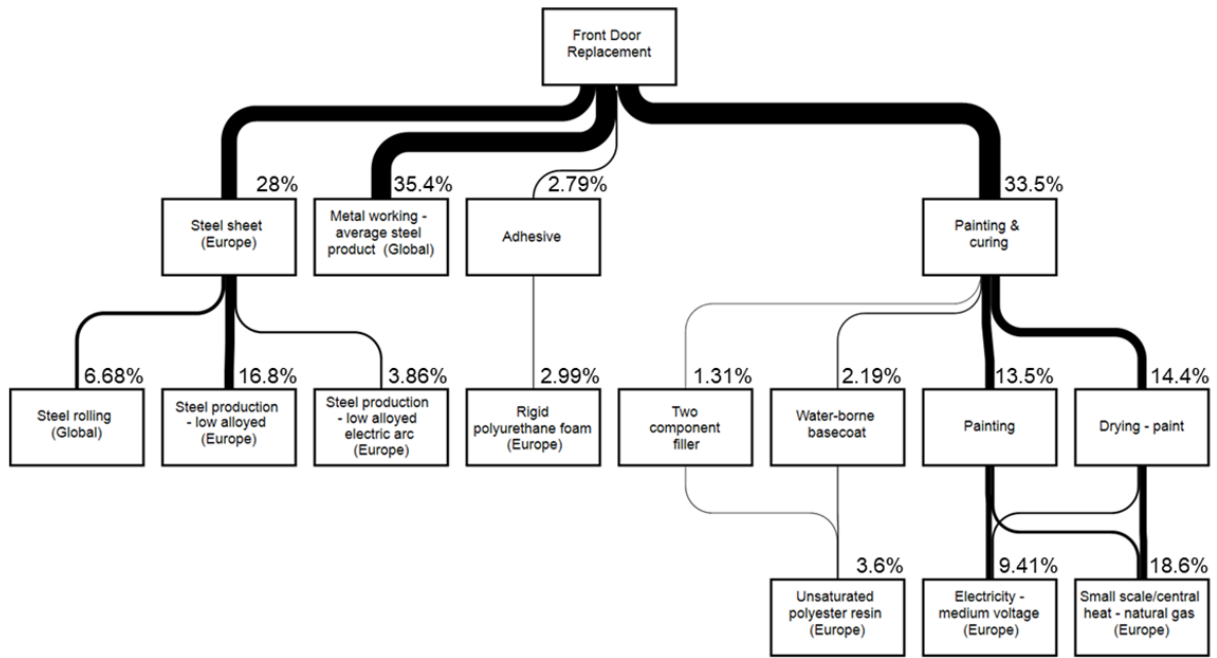
Figure 13 Front door replacement – contribution of GHG impacts by source (1% cut off: European average scenario)

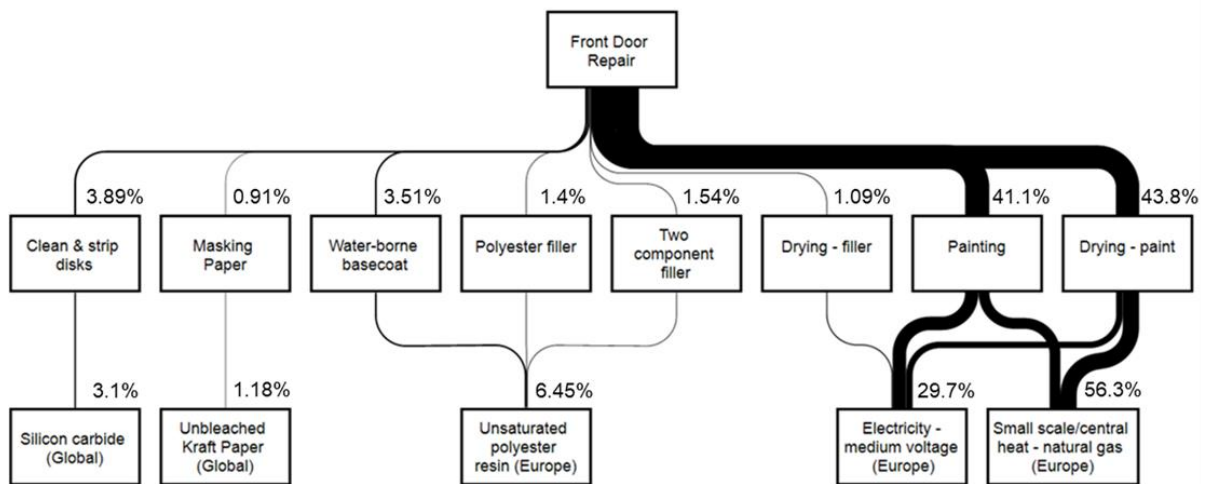
Figure 14 Front door repair – contribution of GHG impacts by source (1% cut off: European average scenario)

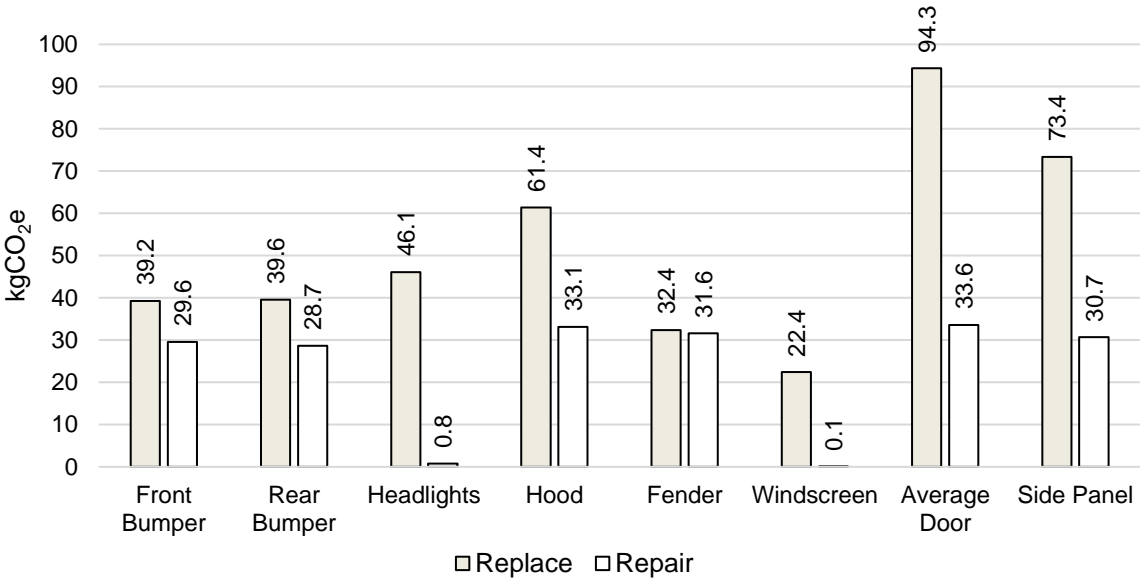
Figure 15 Emissions from EU average repair and replacement (kgCO<sub>2</sub>e)

Below in Figure 15 is presented the average GHG emissions associated with all body parts. For every part analysed, repair has a lower carbon footprint associated with it than replacement does. The magnitude of this difference ranged from 99% in the case of headlights and the windscreen to 4% in the case of the fender.

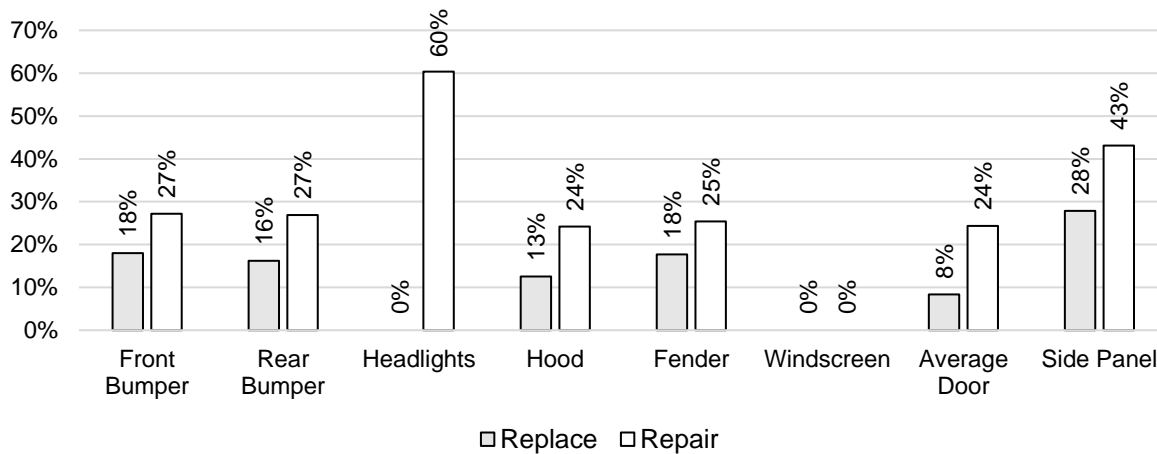
*Figure 18 Emissions in the solar PV scenario as a percentage of the EU average scenario*

This then raises the question of how a solar-powered “eco” workshop would affect the overall emissions from the repair or replace process. As anticipated, when considering the impact that electricity mix has on overall emissions, on average the emissions from damage rectification drop significantly, particularly for those parts that need proportionally more work done in the workshop. Headlight repair benefits the most from such an “eco” workshop, while neither windscreen replacement nor repair see a similar drop in emissions (see Figure 18).

This is due to the modelling assumption that no or negligible workshop electricity consumption takes place during either the repair or the replacement processes for windscreens.

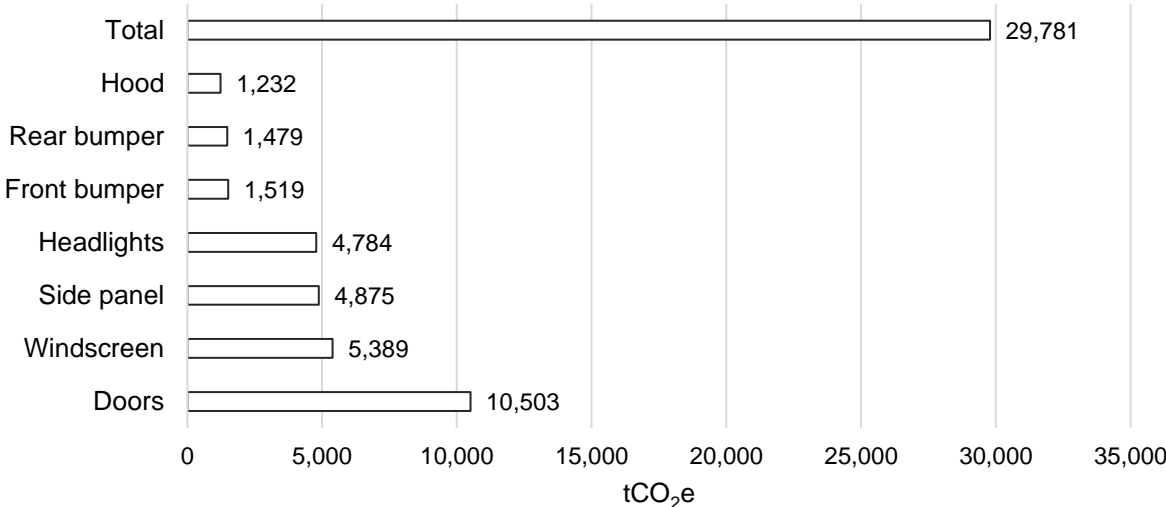
Figure 19 Total emission savings from a 2% increase in the number of part repairs in Europe (tCO<sub>2</sub>e)

The findings from this report are clear regarding how to reduce emissions following a vehicle collision. For those relatively low-cost, low-impact collisions that mainly affect bodywork and windscreens, repair should be the first choice. Demonstrating the potentially significant impacts of just a small increase in repair, a 2 percentage point increase in the repair rate in Europe is estimated to save 29,781 tonnes CO<sub>2</sub>e - equivalent to the energy consumption of 5,148 homes<sup>1</sup>.

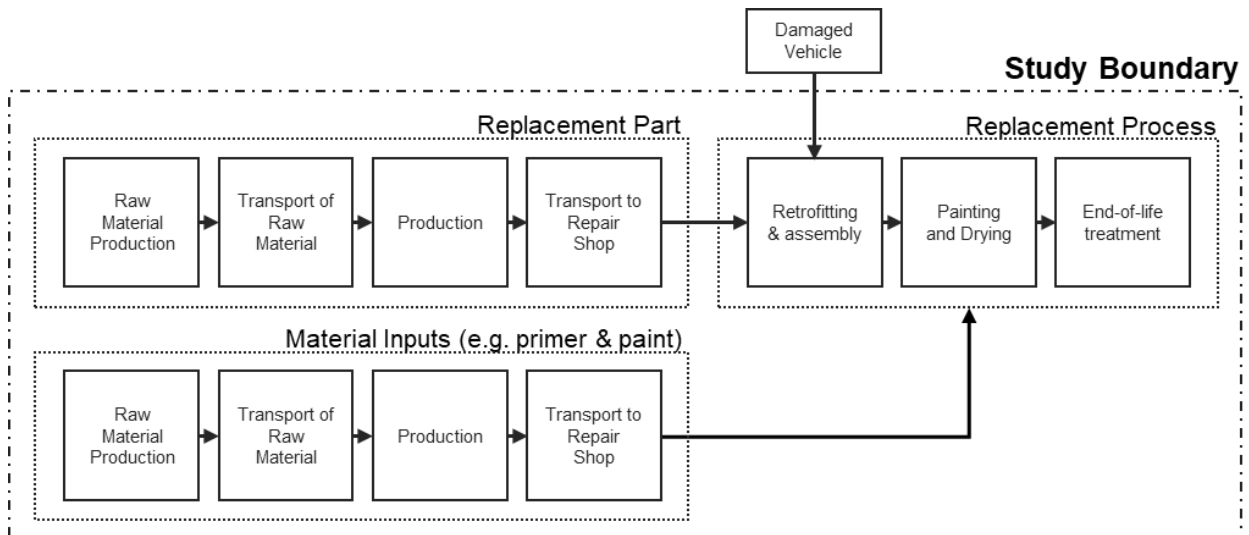
The scenario modelled for the replacement of the front bumper of the ID.3 describes a process in which the whole part is replaced. The cradle-to-gate life cycle impacts of the production of the new part are modelled using a cut-off approach. The modelled processes start with the production of the raw materials and include the manufacture of the replacement part, transport to the workshop, painting, and placement onto the receiving vehicle. Additionally, the modelling includes the removal and end-of-life treatment of the damaged part.

*Figure 21 Study boundary for replacing a front bumper*

The modelling assumes that the front bumper is manufactured in the EU; the average transport distances from the point of manufacture to the workshops in each nation studied have been estimated using Google Maps. As with the repair scenario, it is assumed that the replacement part is painted to colour-match the receiving vehicle. The modelled painting process includes priming (via an adhesion promoter), painting and curing, all of which take place within the repair workshop.

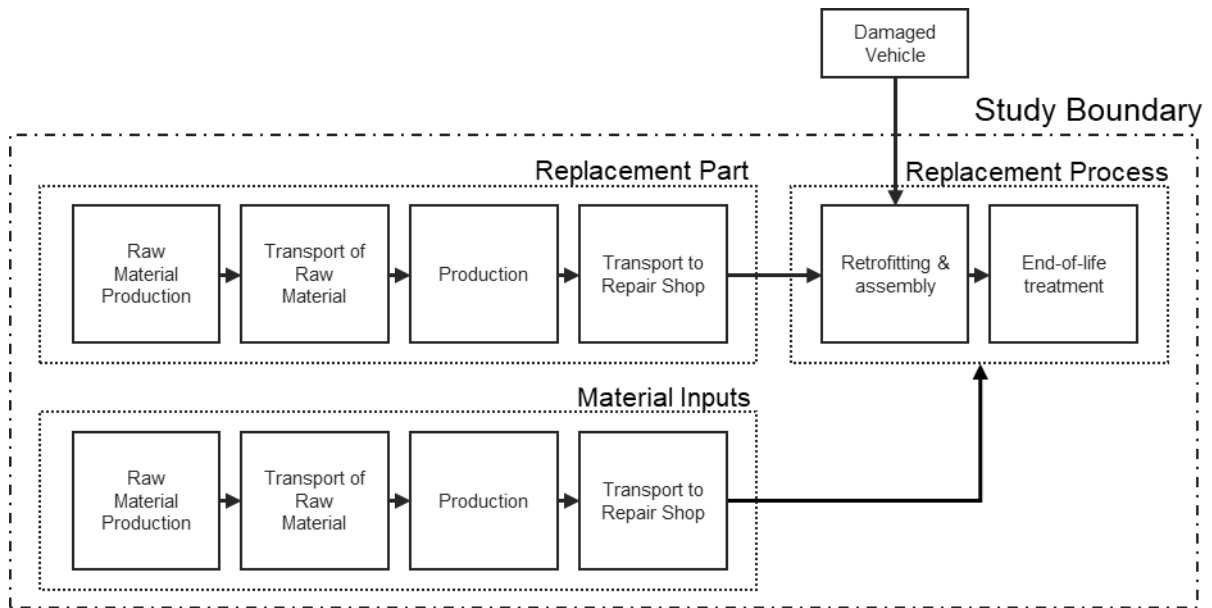
The scenario modelled for the replacement of the windscreen of the ID.3 assumes that the entire part is replaced. The cradle-to-gate life cycle impacts of the production of the new part are modelled using a cut-off approach. The modelled processes start with the production of the raw materials and include the manufacture of the replacement part, transport to the workshop, and placement onto the receiving vehicle. The modelling also includes the removal and end-of-life treatment of the damaged part.

Figure 39 Study boundary for the replacement of a windscreen

The modelling assumes that the windscreen is originally manufactured in Herzogenrath, Germany, with the average transport distances from the point of manufacture to the workshops in each nation studied estimated using Google Maps. As for repair, it is also assumed that the removal and replacement of the windscreen on the vehicle requires no or negligible energy.

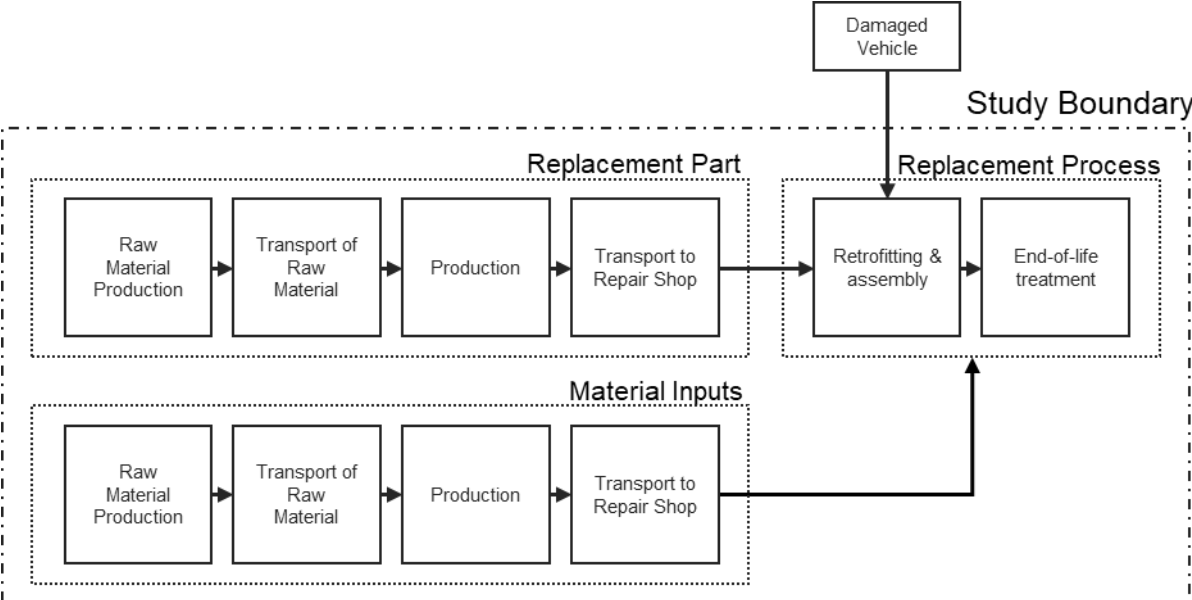
The scenario modelled for the replacement of the headlight the ID.3 assumes that the entire part is replaced. The cradle-to-gate life cycle impacts of the production of the new part are modelled

using a cut-off approach. The modelled processes start with the production of the raw materials and include the manufacture of the replacement part, transport to the workshop, and placement onto the receiving vehicle. In addition, the modelling includes the removal and end-of-life treatment of the damaged part.

Figure 42 Study boundary for the replacement of a headlight

The modelling assumes that the headlight is originally manufactured in the Czech Republic, with the average transport distances from the point of manufacture to the workshops in each nation studied estimated using Google Maps.
